# ROCKY MOUNTAIN STEEL PIERING INCORPORATED

## CASE STUDY

**Project:** Martin Residence, Aurora, Colorado

**Underpinning Contractor:** Rocky Mountain Steel Piering, Inc.

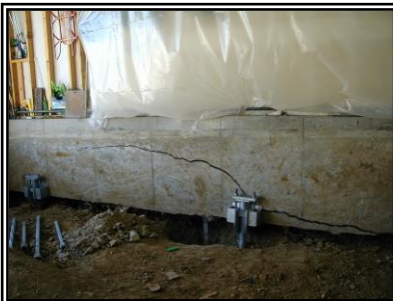
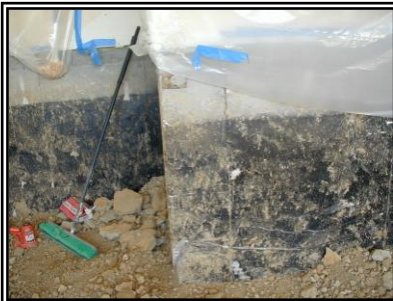
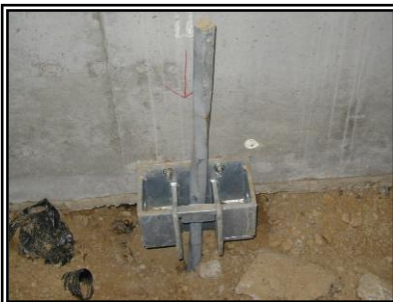
The home consists of a one-story structure with partial basement and partial crawlspace, supported on a drilled concrete pier foundation system. The majority of the home experienced differential vertical foundation movement, which has caused foundation wall cracks, door operation problems and drywall distress to the home.

The repair to the affected foundation system consisted of installing helix piers along the foundation walls, clipping and detaching the existing concrete piers from the foundation, re-leveling the foundation, re-voiding the foundation walls, installing an interior perimeter drain system and repairing the foundation wall cracks. The helix piers were installed by Rocky Mountain Steel Piering, Inc., utilizing a portable torque head to advance the piers into the ground. The helix piers were 1-1/2-inch rounded corner square steel shafts with a single 8-inch helix near the base of the lead section. The tops of the piers were attached to standard underpinning brackets, which were fastened to the base of the foundation walls, and to new construction brackets, which were embedded in reinforced concrete beams at each column location. After the piers were installed and fastened to the foundation walls, the tops of the existing concrete piers were clipped, the foundation was re-levelled as much as possible, and the base of the foundation walls were re-voided. An interior drain system was installed to prevent water accumulation below the foundation system.
