ROCKY MOUNTAIN STEEL PIERING INCORPORATED

CASE STUDY

Project: Bensaid Residence, Littleton, Colorado

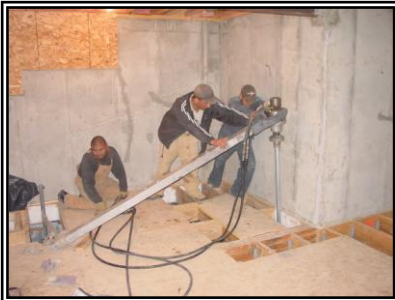
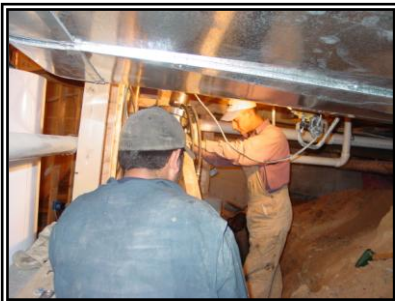
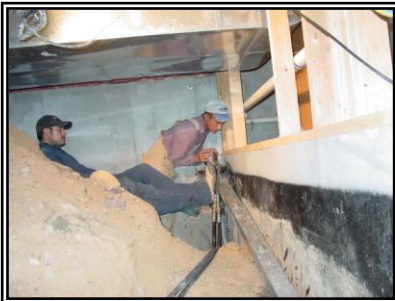
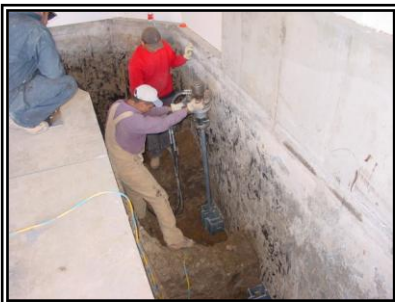
The home consists of a two-story structure with partial basement and partial crawlspace, supported on a drilled concrete pier foundation system. The front and central portions of the home experienced differential vertical foundation movement, which has caused foundation wall cracks, door operation problems and drywall distress to the home.

The repair to the affected foundation system consisted of installing helical steel piers along the foundation walls, clipping and detaching the existing concrete piers from the foundation, re-voiding the foundation walls and repairing the foundation wall cracks. The helical steel piers were installed by Rocky Mountain Steel Piering, Inc., utilizing a portable torque head in order to advance the piers into the ground. The helical steel piers consisted of 1-1/2-inch rounded corner square steel shafts with a single 8-inch helix near the base of the lead sections. The piers were advanced to an average depth of 20 feet into the ground to support the design load of 25,000 lbs. The tops of the piers were attached to standard underpinning brackets, which were fastened to the base of the foundation walls. After the piers were installed and fastened to the foundation walls, the tops of the existing concrete piers were clipped and the base of the foundation walls were re-voided.
